# Manhole Inspection Summary

Manhole # S05CC2008MH

Insp Date: **8/8/06 1:47 PM**

**Location** Address: **6008 BAYWOOD AVE**

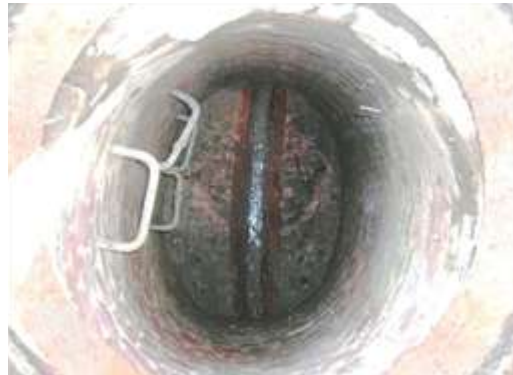
Top View

Evidence of surcharge - Bench debris.

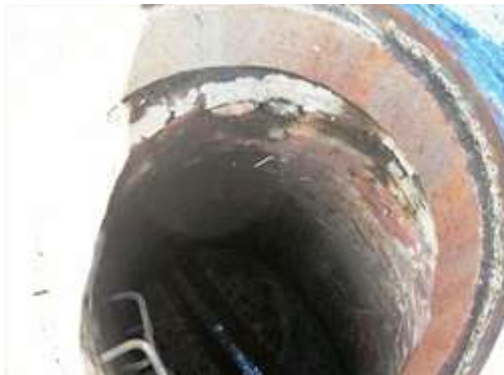
Defect

Frame leaks. Adjustment deterioration and infiltration. Corbel and Barrel infiltration.

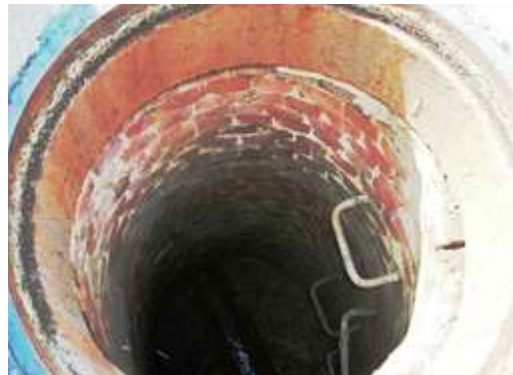
Defect

Frame leaks. Adjustment, Corbel and Barrel infiltration - other side.

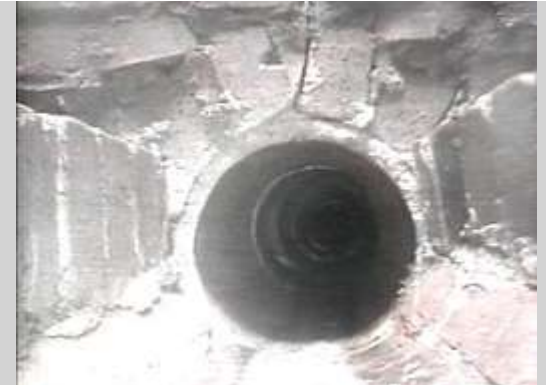
### 8 in. Circular Gravity Sewer Pipe Out @ 12 O'Clock

Barrel deterioration and infiltration.

Infiltration: **Evidence** Pipe Seal Cond: **Unknown**

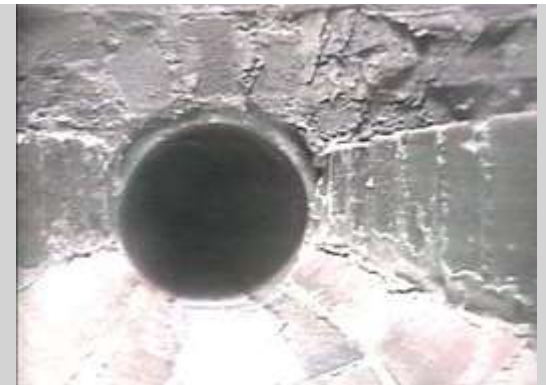
### 8 in. Circular Gravity Sewer Pipe In @ 6 O'Clock

Infiltration: **Evidence** Pipe Seal Cond: **Unknown**
